Re: abandoned building at 395 West Main Street, BDA# 13011
Site Visit Summary and preliminary assessment of risks

395 W Main St Inspection -report-2012-11-28-update

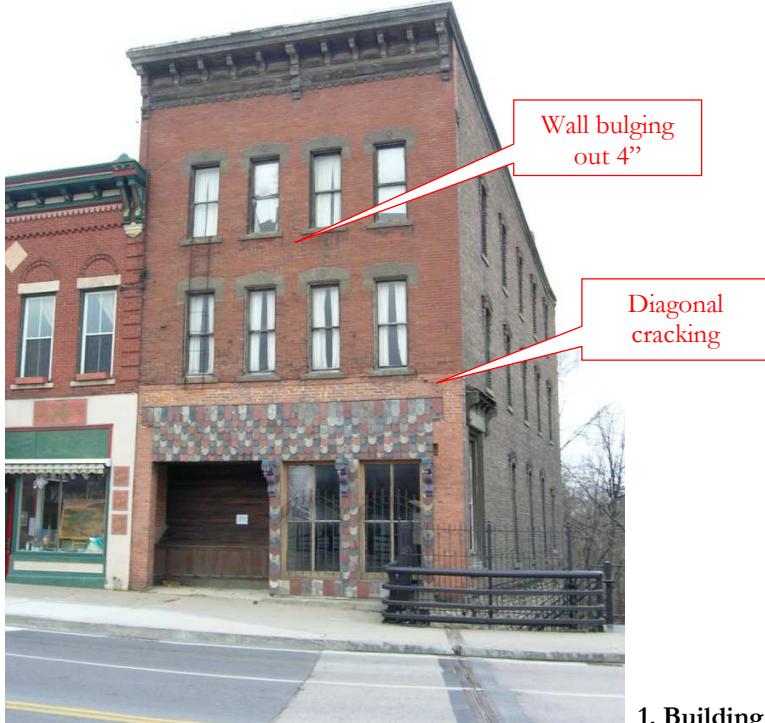
- Diagonal cracking on the brick masonry above the steel header for the main floor store front opening indicating possible minor settlement of the bearing for this beam. (**no change noted**) **Photo #1**

6. **Cracks in Brick Façade** - Diagonal cracking was noted at the south wall above the steel header supporting the wall above the storefront opening. It was also noticed that the brick wall above is leaning out approximately 4" towards the street. This may be the result of overloading of the beam or insufficient tie-in to the floor structure. Failure of this wall would most certainly result in its collapse onto the sidewalk and street in front of the building.

1. Building Front from South

- h. Repair cracks in brick masonry walls.
 - i. Point stone masonry of east wall over river.
 - j. Investigate bow in front brick masonry wall and install necessary repairs

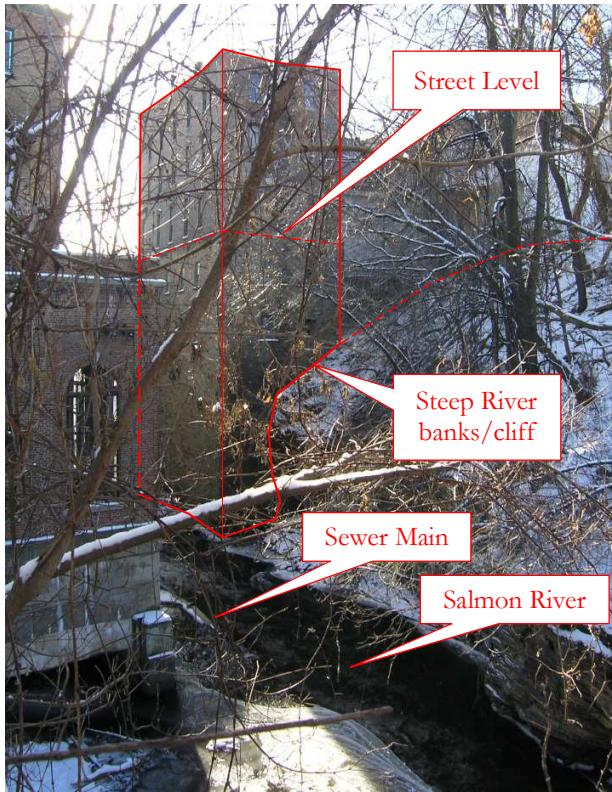
2. Building Back from Northeast

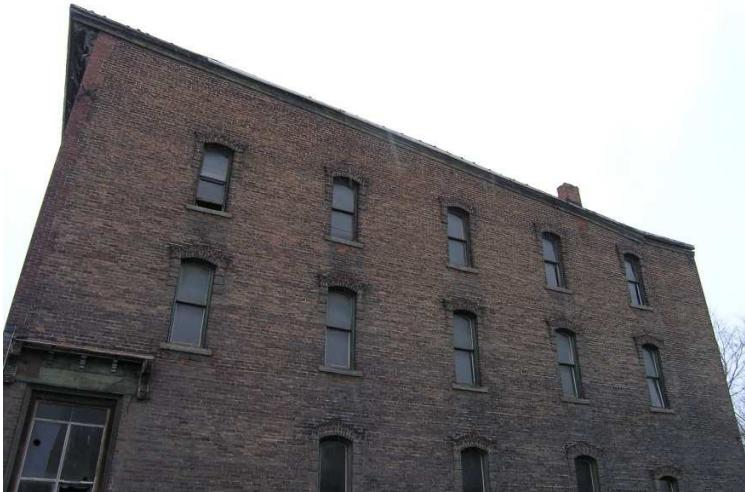
3. Building East Wall top

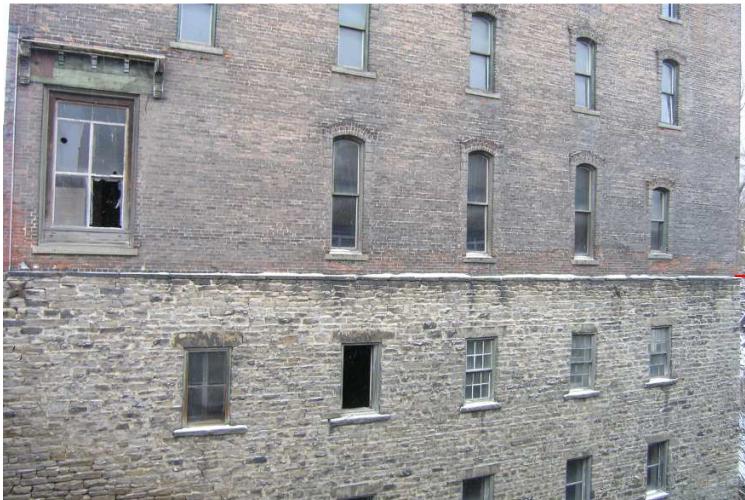
4. Building East Wall middle

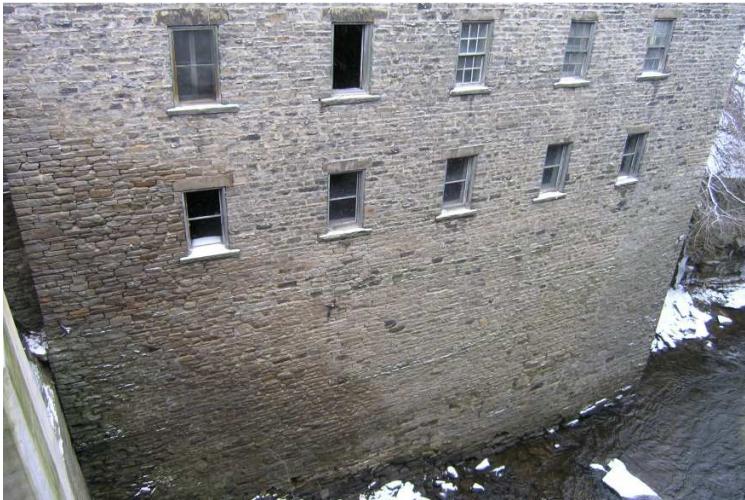
- A triangular area of dark discoloration occurs on the outside of the east stone masonry wall adjacent to the bridge abutment. This area also shows significant erosion of the mortar joints in the stone masonry. (**no change noted**) **Photo #5**

4. The dark area of the east wall noted above has significant mortar loss at the outside of the joints. This is most likely due to the effects of salt spray from snow plowing operations on the bridge. This is not currently a structural issue but may become one if allowed to continue.

5. Building East Wall bottom

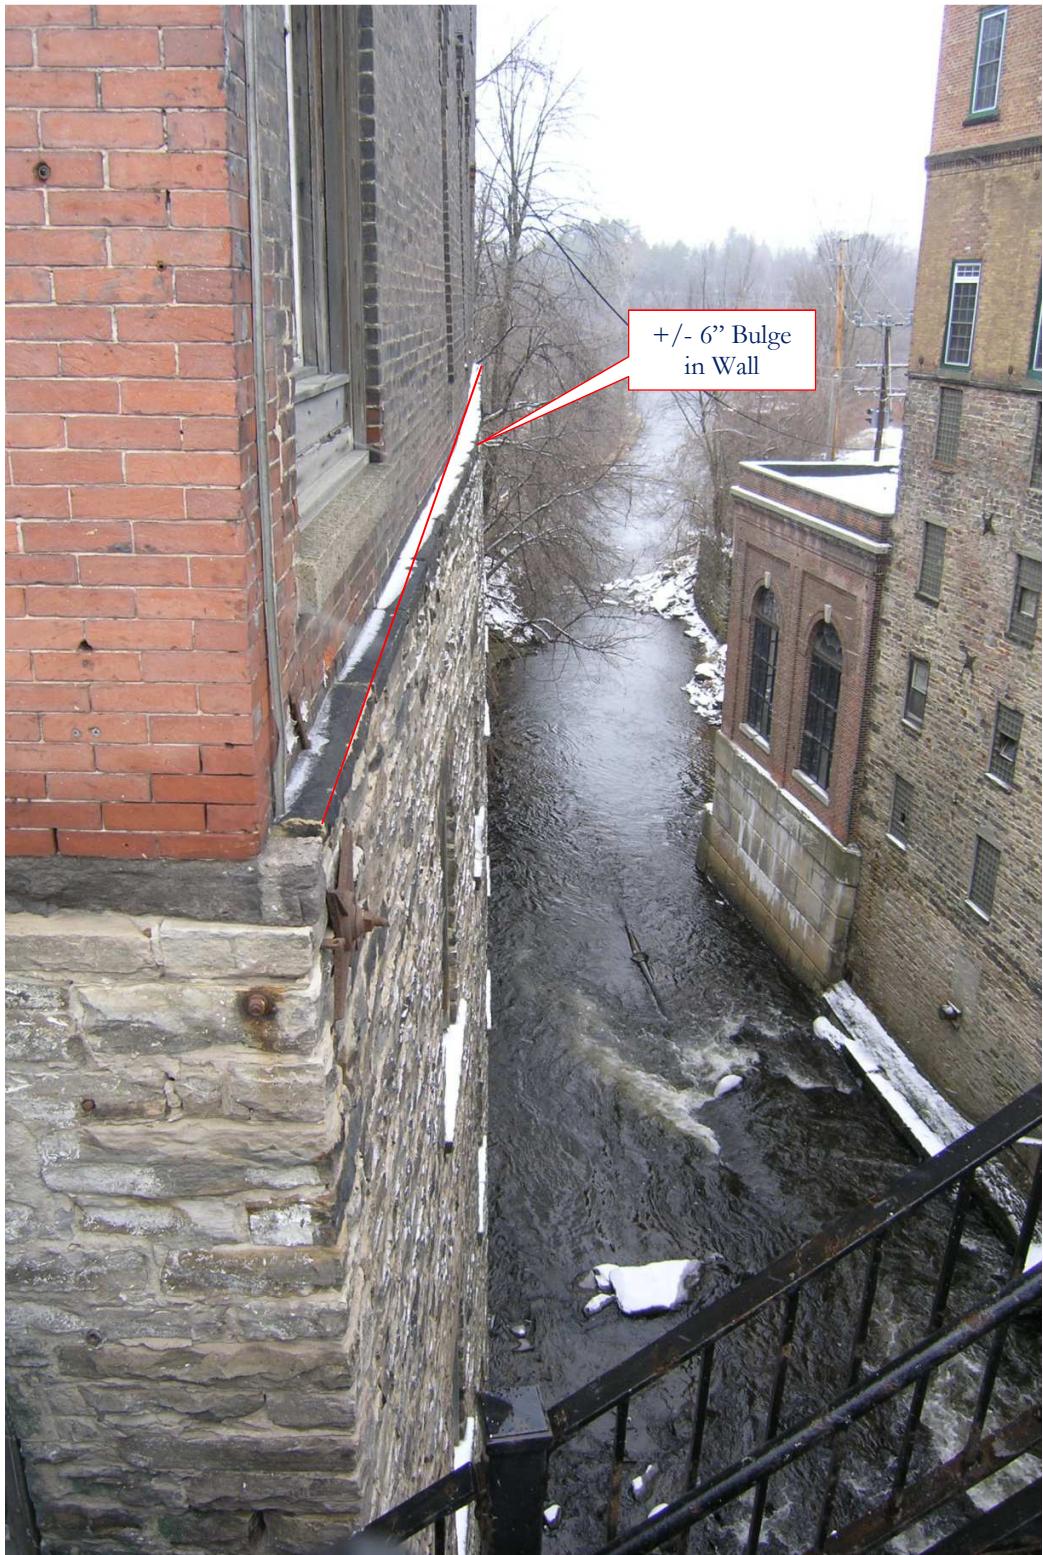
- Bulging outward of the front brick masonry wall at the second floor level by approximately four inches. (**no change noted**) **Photo #1**
- Significant bulging outward of the east wall by approximately 4" inches at the main floor level. It appears that this bulge may carry down to the buildings foundation but this could not be confirmed. (**by analyzing photographs, the bulge appears to have increased to 6"**) **Photo #6**

1. **Exterior Walls** - The most significant problem of this building is the questionable soundness and stability of the exterior walls, particularly the east stone masonry wall which is founded in the river bed. This wall is supporting all of the interior floors. Failure of this wall would likely result in complete and catastrophic failure of the entire building. This wall has a noticeable bulge, approximately an 8" displacement outward, at the center of the main floor, basement and sub-basement levels. It has not been determined if this is due to instability (buckling) of the wall or due to a shifting of the foundation. This movement has already pulled the support beams for the sub-basement floor out of their wall pockets resulting in failure and collapse of approximately half of the sub-basement floor. Collapse of this floor caused collapse of several pipe columns supporting the basement floor above, exacerbating the buildings problems. This movement has also pulled the beams supporting the basement and floor joists for the main floor out of their wall pockets, reducing bearing to an inch or less in some cases. Further movement of this wall could cause failure of the basement and main floors, initiating catastrophic failure of the entire building.

6. Building East Wall bulge

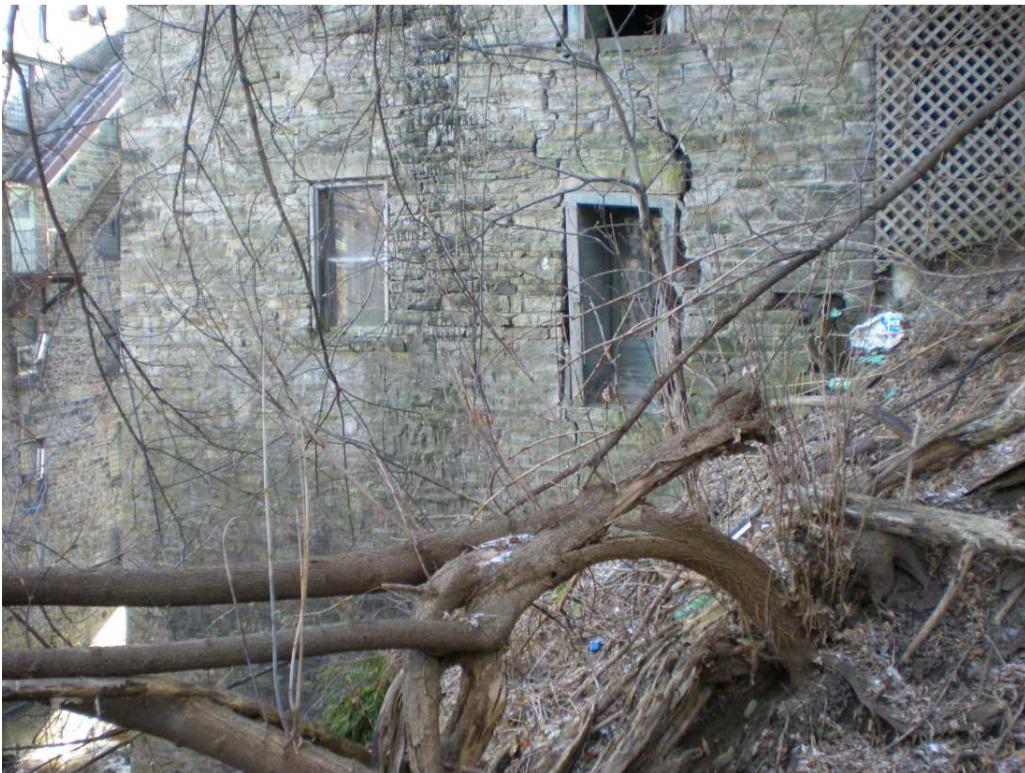
- Vertical cracks in the stone masonry walls at the south east corner at the basement and sub-basement levels, (**no change noted**), **Photo #8**, at the middle of the north wall at the sub-basement level. (**no change noted**) **Photo #7**

3. **Vertical Cracks** - There is visible shearing in the plane of the north end wall at the northwest corner of the building. This appears to be the result of foundation sliding failure at this location though the foundation could not be seen due to debris. It appears that the north wall has spread apart by 2"-3" resulting in large vertical cracks in the stone masonry wall around door openings at the basement and subbasement levels. These cracks have telegraphed up through the wall to the main floor level. It appears that the northwest corner of the building may have settled by an inch or less. Two similar vertical cracks were noted in the brick masonry of that portion of the

7. Building Wall Cracks at North Wall, Sub-basement Level

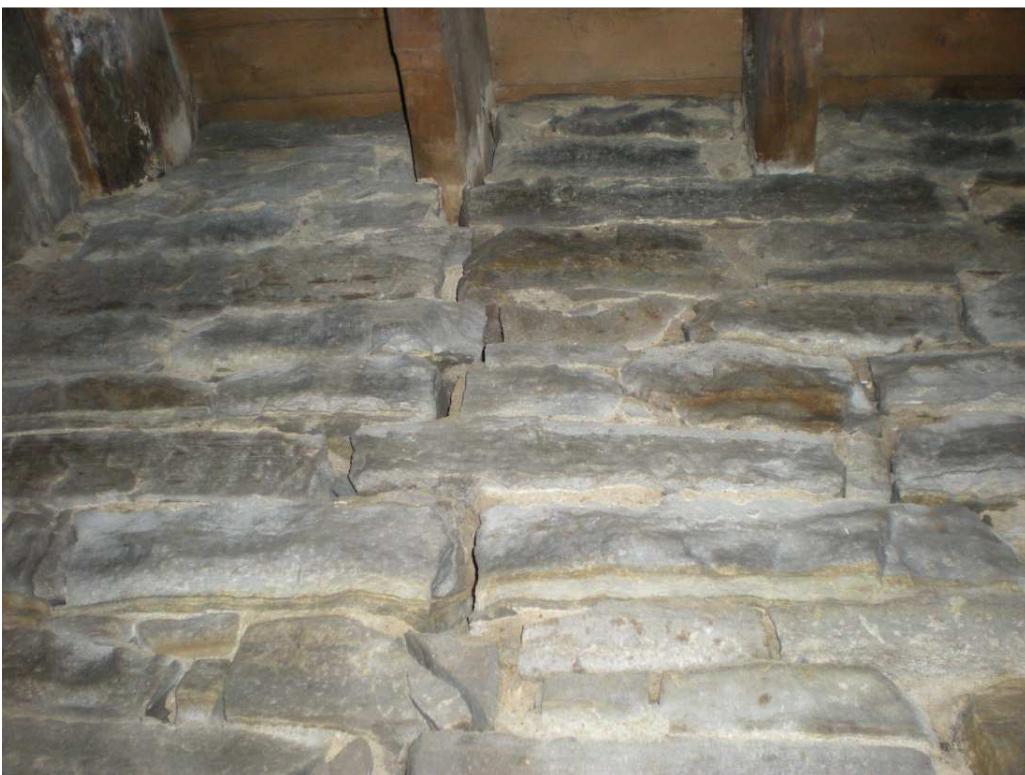
2. The stairs between the 2nd and 3rd floors have settled and are inadequately supported.
3. A vertical crack was noted at the interior of the stone masonry at the south east section of the basement and sub-basement walls.

8. Building Wall Cracks at South Wall, Interior Sub-basement Level

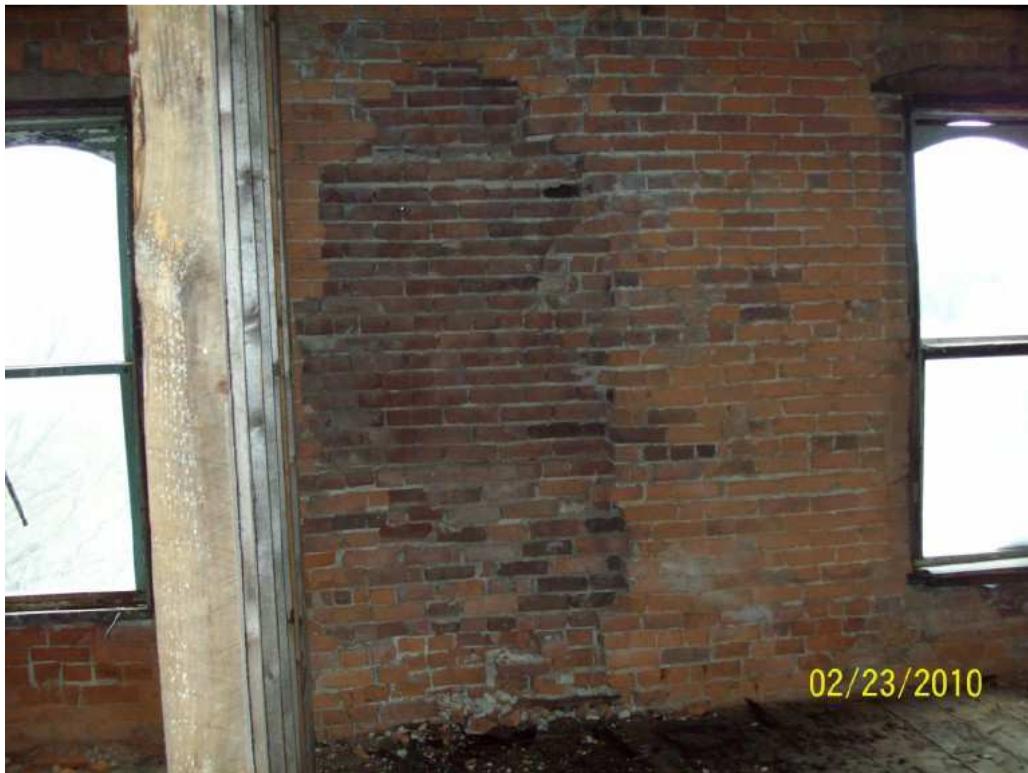
- A significant leak in the roof at the rear of the building including possible rotting roof structure. (**no change noted**)
- Partial collapse of the rear brick wall at the top floor below the roof leak. The interior layer of brick has fallen onto the floor. (**no change noted**) **Photo #9**

5. **Leaking Roof** - It was noted that the roof leaks. These leaks have likely caused a partial collapse of the inside of the north wall at the third floor by freeze thaw action on the brick masonry. The leak is at the roof valley adjacent to the scupper so it may cause considerable infiltration of water. If this is allowed to continue, it will compromise the integrity of both the roof and floor structure.

9. Failing back wall at 3rd floor

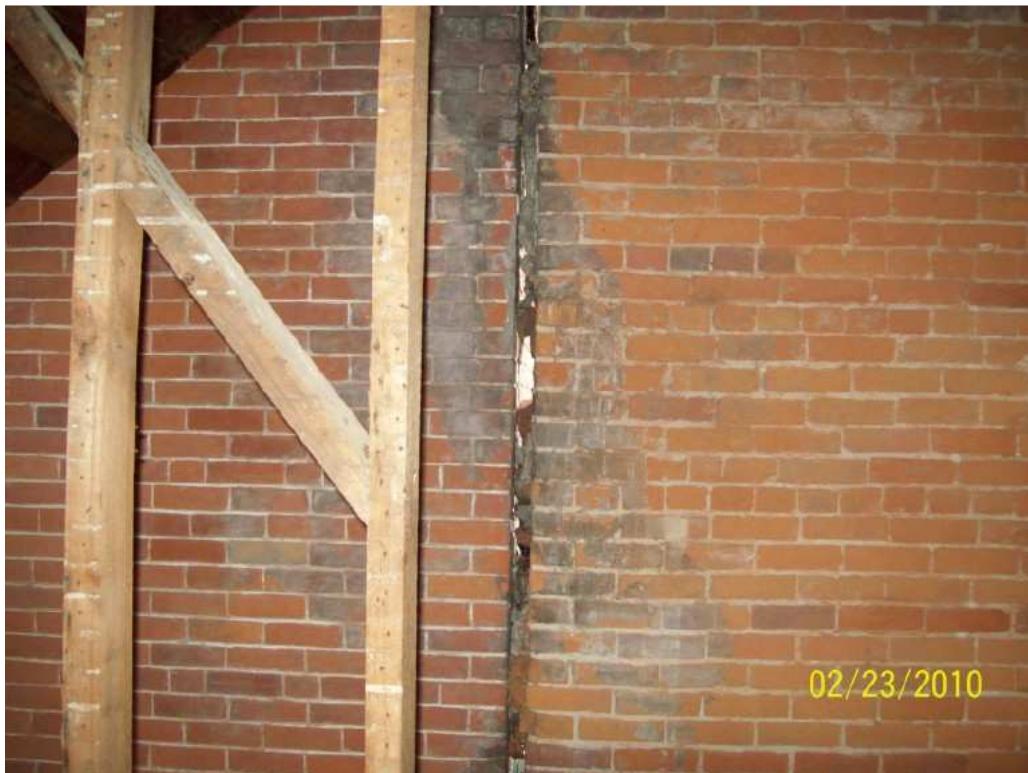
- Vertical cracks of up to two inches in the brick masonry walls on the west wall of the building at the joint between the adjoining building structure and the building in question. (**no change noted**) **Photo #10**

west wall that extends above the adjoining building at the second and third floors. One of these is a vertical separation where this building abuts the construction of the adjoining building. These cracks are consistent with settlement of the north west corner of the structure.

10. Spreading Gap in Wall at 2nd Floor

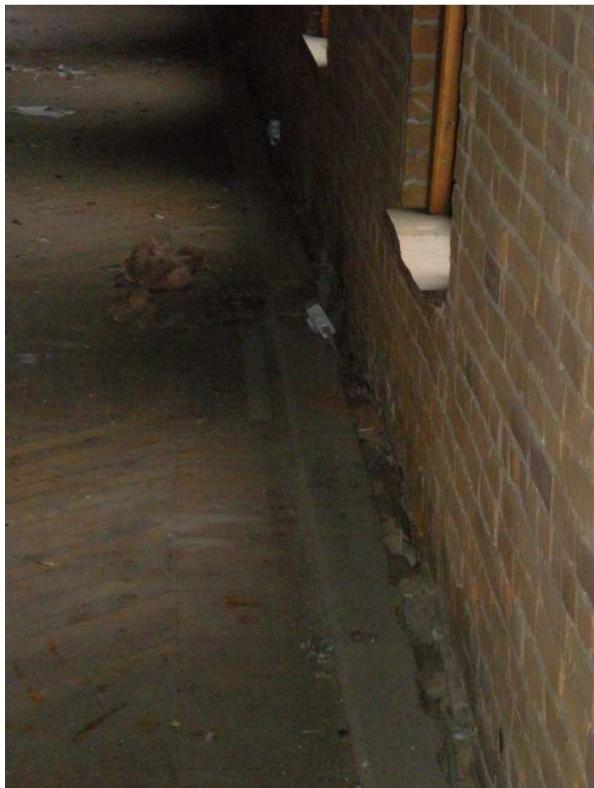
- Main floor joists pulled out from both east and west walls. (**no comparative photographs or measurements taken**) **Photo #11**

11. Gap at East Wall at 1st Floor

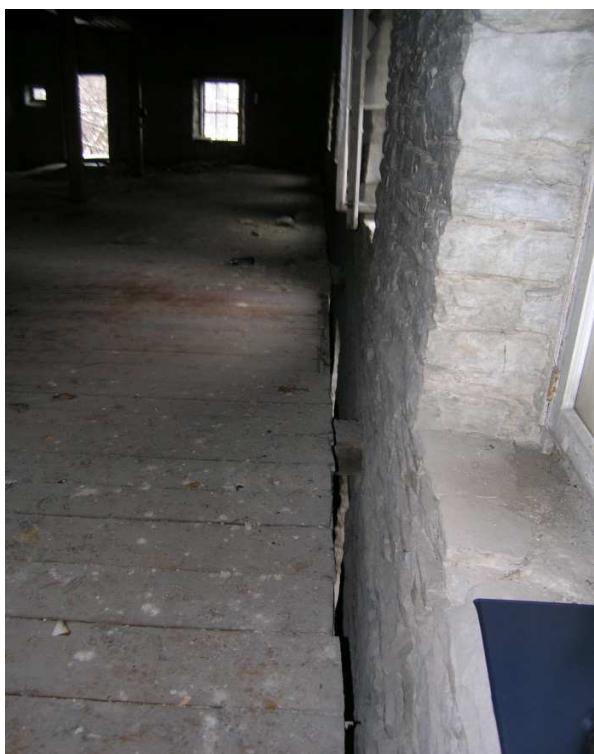
- Basement floor beams pulled out from east wall. (**by analyzing photographs, the gap between the east stone wall and the floor structure appears to have widened by 2"**) **Photo #12**

12. Gap at East Wall at Basement Floor

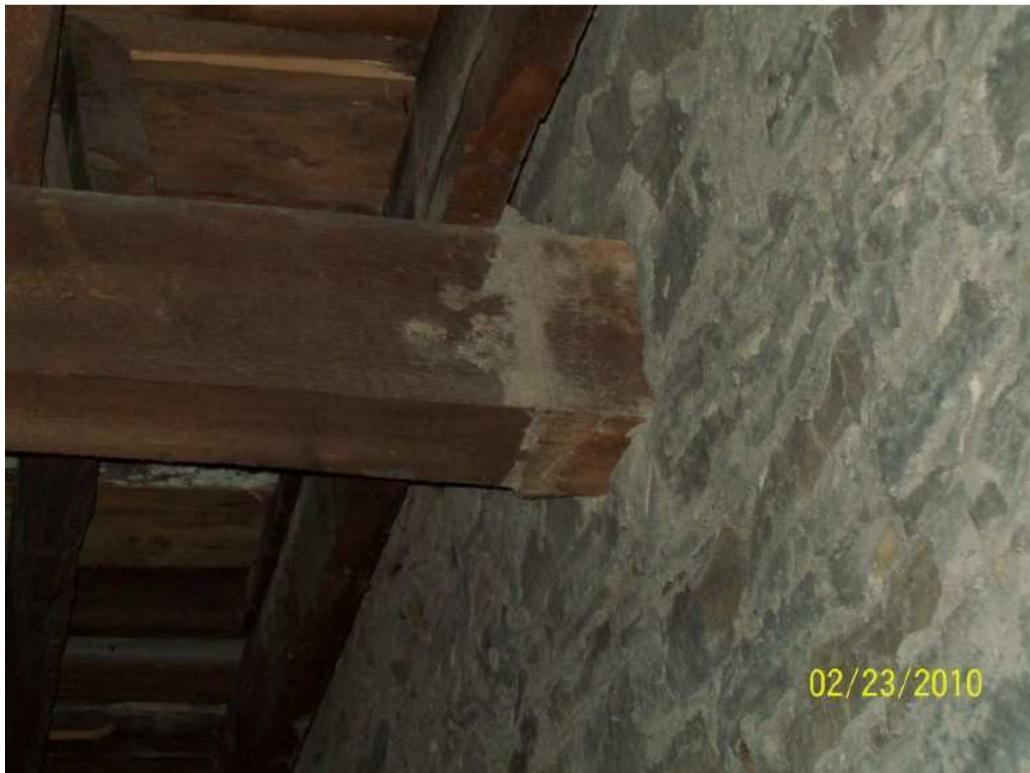
13. Floor Beam Pulled Out From Wall at Basement Floor Structure

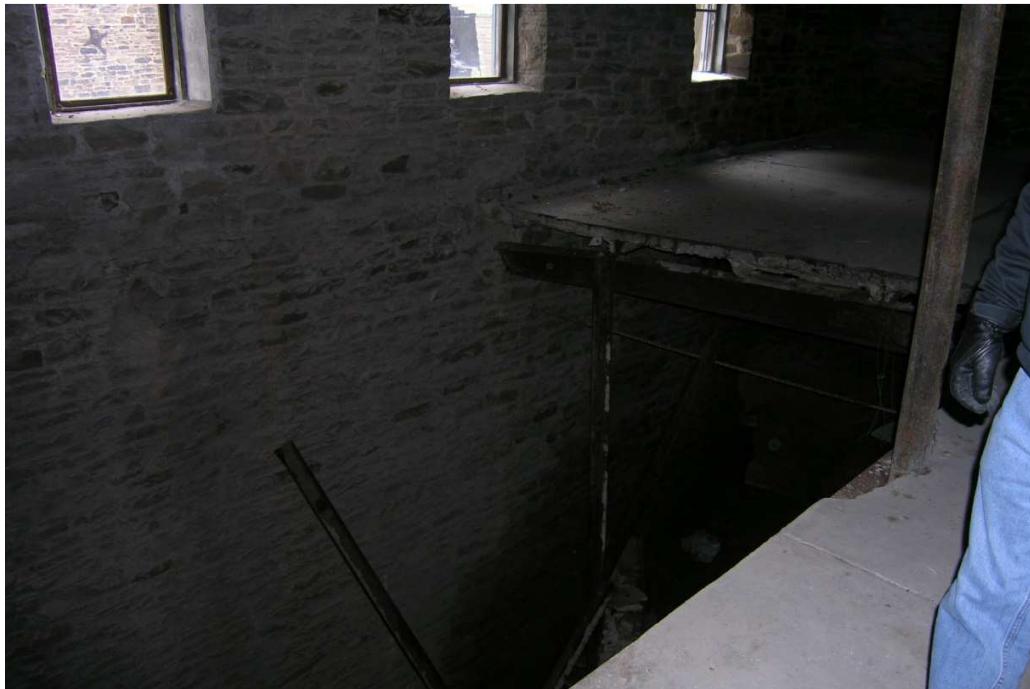
- Approximately half of the concrete and steel sub-basement floor has collapsed into the void below the sub-basement floor. Several columns are missing supporting the basement floor beams. (**no change noted**) **Photo #14**

2. **The sub-basement floor has collapsed.** Approximately half of this floor has collapsed. The most likely cause is the movement of the outside wall noted above. It is also possible that it collapsed under its own weight due to poor construction materials and poor design and this event resulted in the movement of the east wall. The loss of this floor has reduced the lateral restraints on the outside wall, rendering it less stable. The portions of the floor still standing are significantly compromised and may eventually collapse from their own weight. **This floor is extremely unsafe and no one should enter this portion of the building for any reason.**

14. Collapsed Sub-Basement Floor
